**E-39 - Modality Insight on the Anterior Cruciate**

**2026 Spring Symposium**

## **Modality Insight on the Anterior Cruciate**

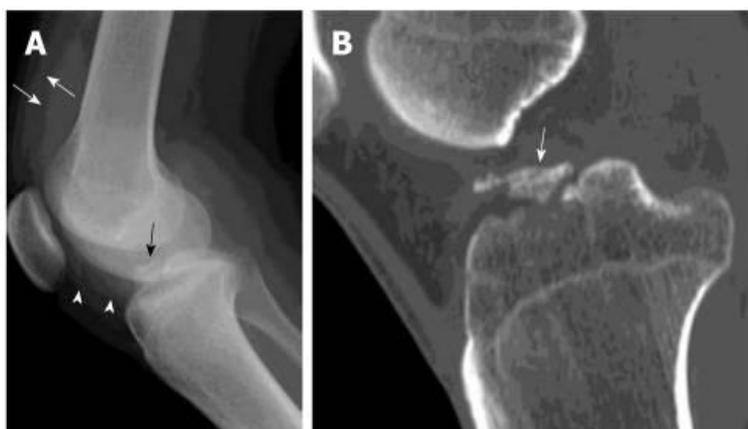
(Display of tibial insertion avulsion fracture) National Library of Medicine <https://pmc.ncbi.nlm.nih.gov/articles/PMC3302044/#B14>

indirect signs of an ACL injury. X-rays use high energy waves that pass through the body and create images based on tissue density wavelengths that allow them to pass through the body. As x-rays travel through the body, some of their energy particles called photons are absorbed while others continue to pass through. Dense structures such as bone absorb more photons and appear white, while less dense structures such as tissue and air absorb less photons, creating a darker image (Asrt.org, 2020). X-rays cannot show the anterior cruciate ligament. They are mainly used to check for bone injuries, such as fractures. While X-rays do not provide information about ligament damage, they are helpful in deciding if further imaging, such as an MRI, is needed. According to Wing hung (2022) and his research team, “On radiography, there are several indirect signs that could raise suspicion of underlying ACL injury. Avulsion fracture of ACL at the tibial insertion or femoral origin can be found on radiographs but is better defined by computed tomography (CT)[14,15] (Figure 1A and B). Avulsion fracture of lateral tibial rim (Segond fracture) (Figure 2) is commonly associated with an ACL tear[16-18] and is classically due to avulsion fracture of the iliotibial band though the term has also been applied when there is avulsion of the fibular collateral ligament”(para 8).

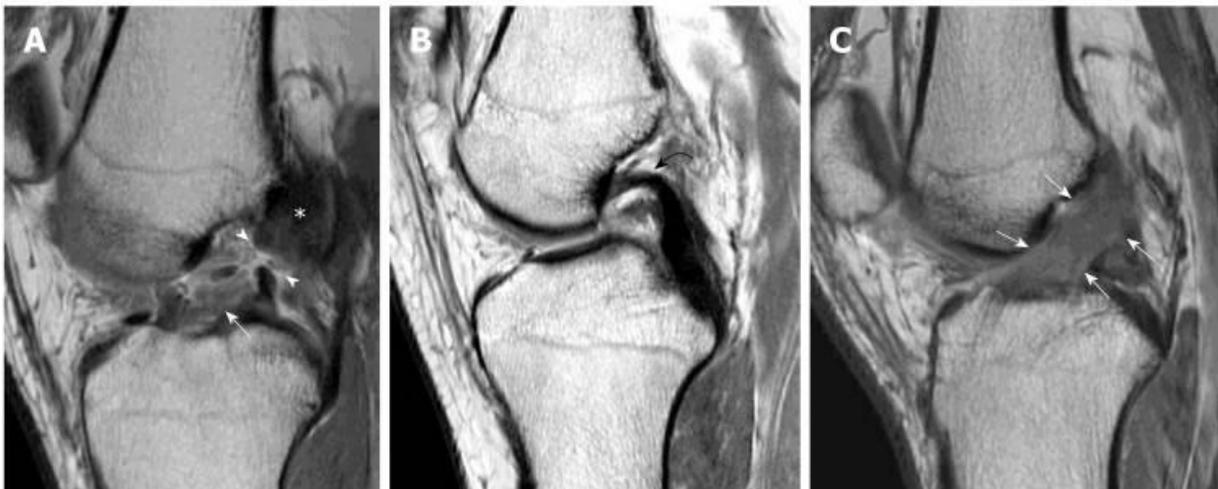
(Visualization of ACL tear) National Library of Medicine <https://pmc.ncbi.nlm.nih.gov/articles/PMC3302044/#B14>

Magnetic Resonance Imaging is the preferred method to diagnose a suspected ACL injury. MRI works by placing a patient in a strong magnetic field, where a radiofrequency pulse is applied causing atoms to move out of alignment. When the MRI pulse is stopped, atoms return to their normal position and data is collected on the atom's movement. With the help of computers these signals are collected and used to make an image of atoms that were moved (Asrt.org, 2020). The ability of MRI to visualize soft tissue is the reason why it is preferred imaging. Soft tissue such as ligaments, cartilage, surrounding structures such as menisci can help doctors to see if the ACL was partially or completely torn. The scan would take 45 to 60 minutes, and the patient would be placed in a supine position, foot first into the scanner. The affected knee would be placed in a knee coil which would boost the scan to the part of interest. MRI gives Doctors answers within an hour whether surgery is necessary, if the ligament is partially or completely torn, with the scan being at or more than 90% accurate.
